Avoiding Flashover in Medium Voltage Switchgear

Chuck Humphrey

Highvec Canada Inc.

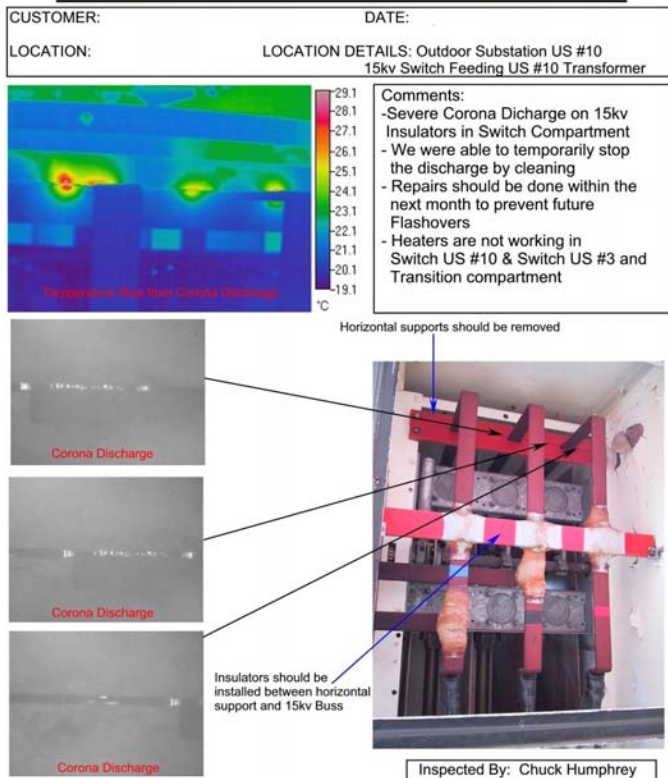
In the case of fig. #3 a thermogram was able to show a temperature rise on the 15kv buss insulators, verified by the ultraviolet corona images. The problem in this case is decay in the horizontal insulators causing electrical stress to initiate the corona. This all started with contamination entering the switchgear, trapping moisture and then under the right conditions started producing corona. Then with nitric acid, ultraviolet light, ozone and carbon deteriorating the insulation the corona eventually spreads on it's own.

Corona at anytime is extremely serious and should be dealt with and eliminated as soon as possible. In our case we can stop the corona with our cleaning equipment. Sometimes permanent and sometimes temporarily, depending on the situation.

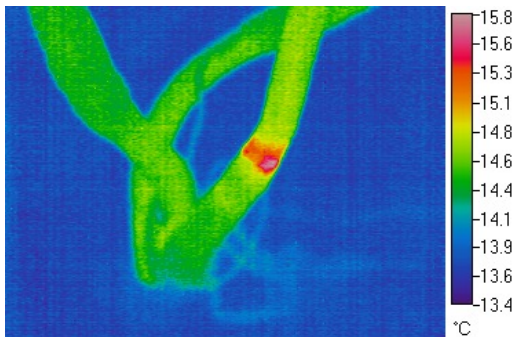
fig. #4

These thermograms represent two different cases of defective stress cones. Fig #4 shows a 5kv shielded cable with a stress cone and fig #5 shows a 15kv shielded cable with stress cone. The temperature rise is minimal, but the problems are very serious. Both stress cones were developing corona underneath the insulation and will eventually flash to ground. I have talked to different electrical thermographers and some believe that if the temperature rise is less than 10 degrees, not to worry about it. As you can see from images #4 and #5 that the temperature rise is less than 2 degrees C .

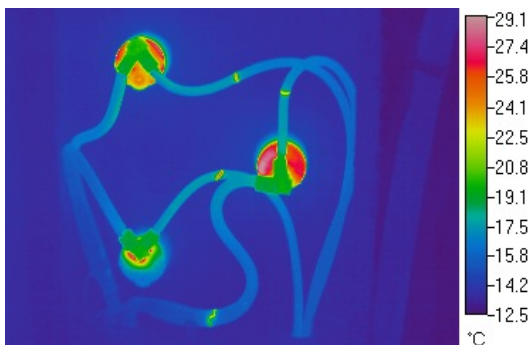
Active corona in fig. #6 shows a 4,160v junction box which is very close to flashover on three phases and had to be rebuilt because the corona damage was too extensive. We were able to temporarily stop the

activity with cleaning which kept it energized until they had a scheduled shutdown. Fig. #7 shows 13,800v conductors and insulators developing a temperature rise from corona discharge.

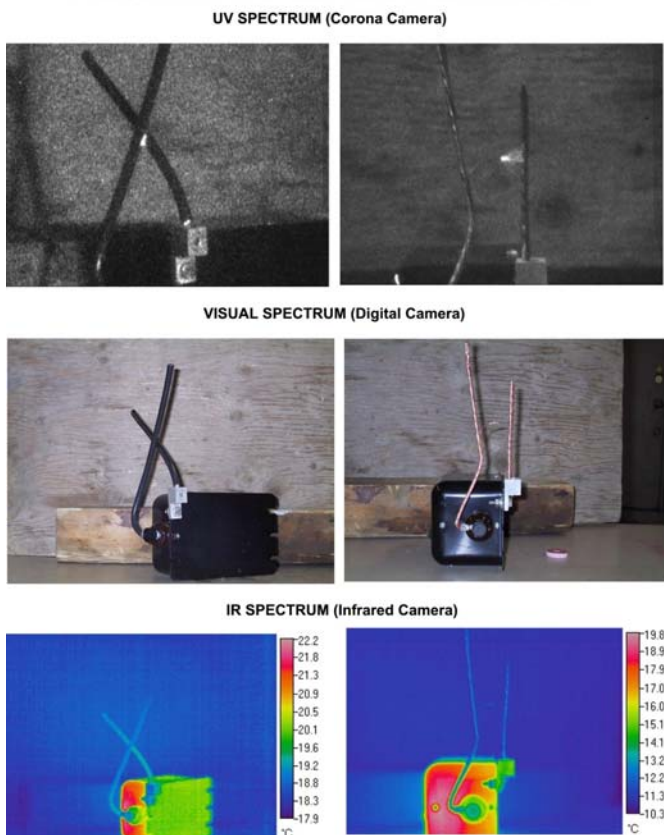
In fig. #12 we show two different scenarios of active corona at 5kv. In the left and right columns we see the three different spectrums all at the same time. At the top we have the UV spectrum using the corona camera and corona is evident. In the middle nothing can be seen in the visual spectrum. At the bottom in the IR spectrum using thermal imaging there is no thermal signature where the corona activity is present.
