Avoiding Flashover in Medium Voltage Switchgear

Chuck Humphrey

Highvec Canada Inc.

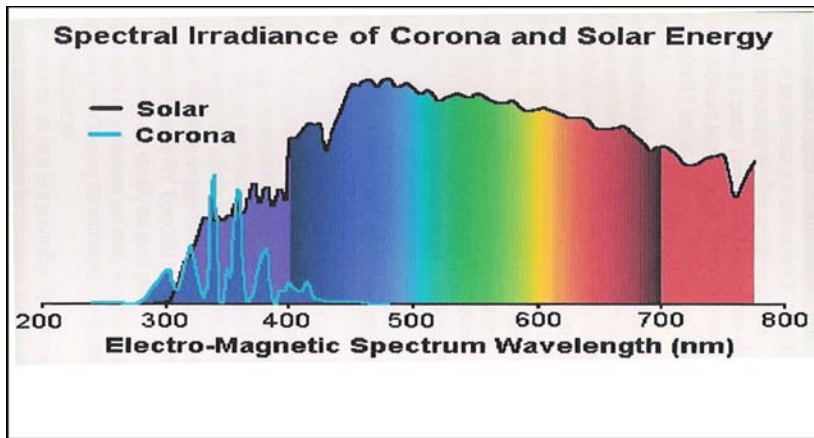
When tracking down corona we have found that it does not always leave a thermal signature. Corona by nature creates little or no heat, but as it progresses into arcing and tracking a thermal signature can sometimes be found. Corona is most intense in the 300 nanometer to 400 nanometer range in the ultraviolet spectrum. When it exceeds the 400nm range corona can be seen in the visual spectrum if there is no interference from background light. Similar to heat coming into the visual spectrum at approximately 585deg. C. at the 700nm level. As shown in fig. #11
